Hydrologic Data Quality Assurance Review of the StormGarden Monitoring Project

Herrera Environmental Consultants, Inc.

Date: January 11, 2019
To: Project File 15-05988-000
From: Dylan Ahearn, Herrera Environmental Consultants, Inc.
Subject: Hydrologic Data Quality Assurance Review of Rotondo StormGarden™ Filter TAPE Monitoring Project

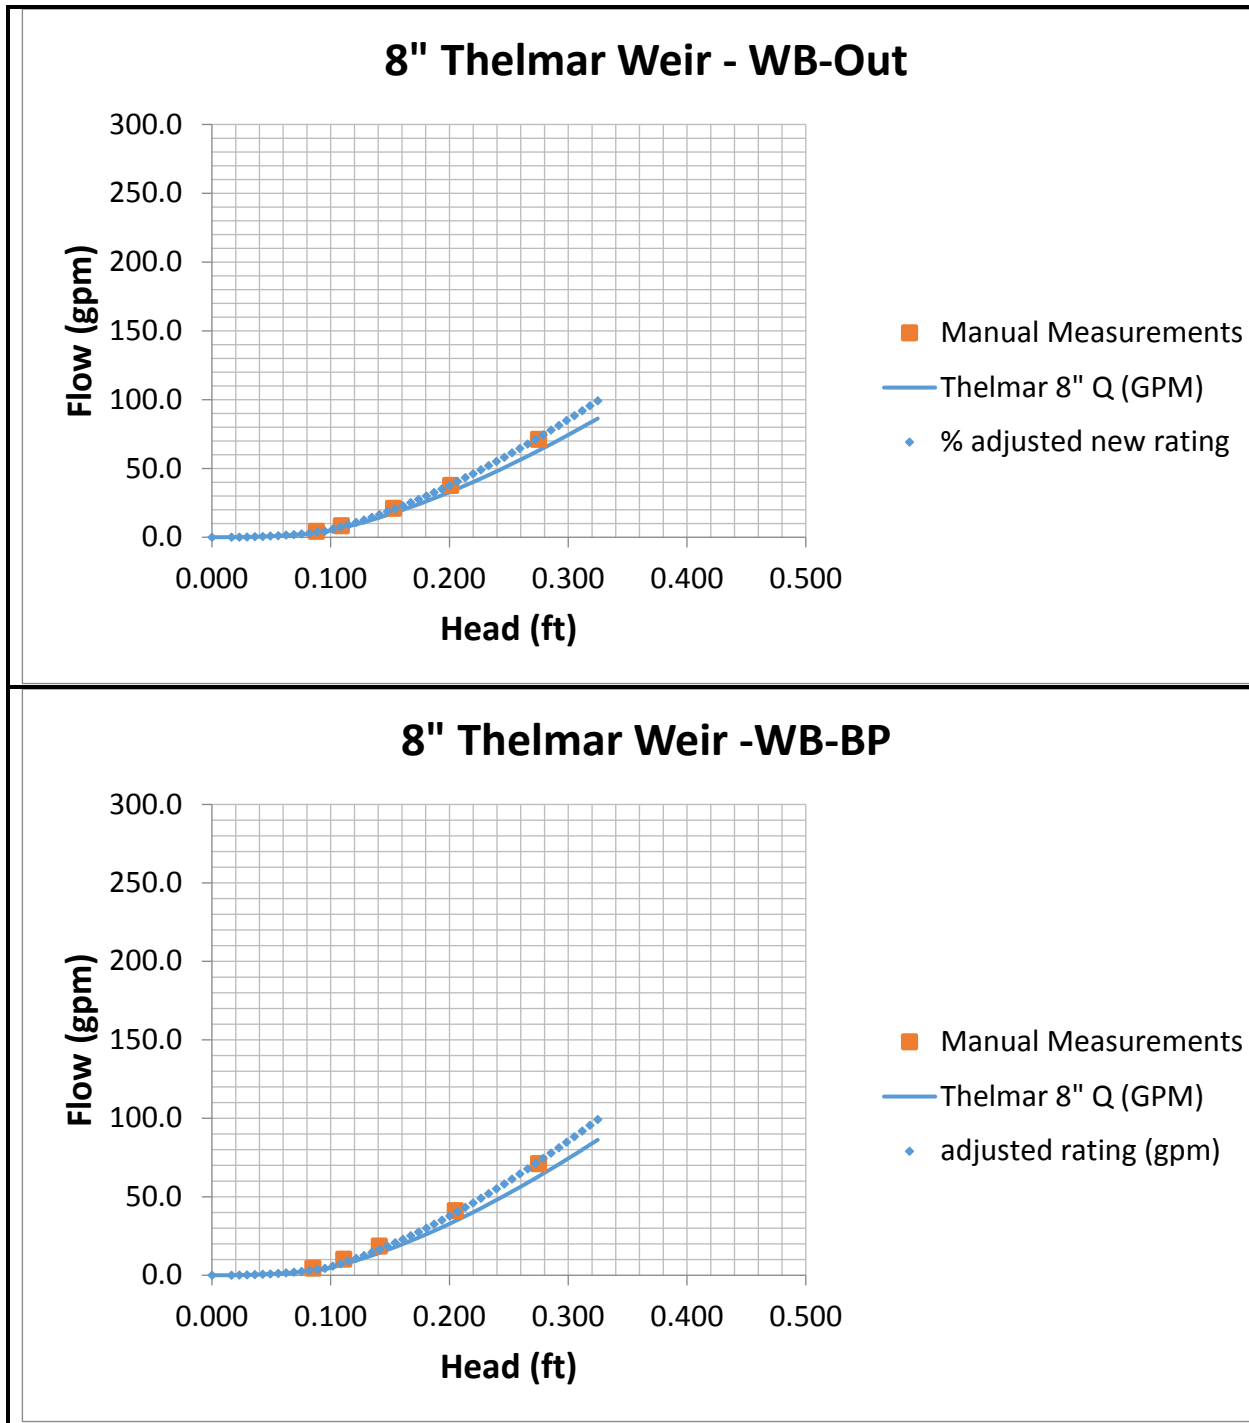
Figure 2. Rating Curve and Thel-Mar Weir Equation for Stations WB-OUT and WB-BP – April 20, 2017.

Bias can also result when primary measurement devices (i.e., weirs) are incorrectly designed or installed in non-ideal conditions. The dimensions of the WB-OUT and WB-BP weirs (both Thel-Mar volumetric pipe weirs [Thel-Mar weirs]) were measured by hand to ensure that the weir equations were appropriate; results from these measurements indicated the weirs appeared to be built to specifications.

However, because past experience has shown Thel-Mar weirs can still produce biased measurements despite being built to specifications (due to elevated approach velocities in sloped pipes), an additional field test was performed to independently check for potential bias in the discharge estimates made at each station. Specifically, field technicians conducted a dynamic flow tests at WB-OUT and WB-BP on April 20, 2017. For this test, a fire hose was attached to a nearby fire hydrant, and flows from the hydrant were assessed using a graduated bucket and timer and a closed channel flow meter (Master Meter 3" FHM). These known flows were then used as the standard for adjusting the weir rating curves. First, the closed channel flow meter was used to discharge a flow rate of 5 gpm. The flow was held at this rate for 5 minutes until a constant and stable water level reading was recorded at the weir's pressure transducer. These values (known flow rate and water level behind the weir) were recorded and then the process was repeated at 10 gpm, 20 gpm, 50 gpm, and 80 gpm. This process was completed for both the WB-OUT and WB-BP weirs. As shown in Figure 2, results from these tests show the WB-OUT and WB-BP weirs were underestimating flows by 15 percent each.
