Filter Panel Assessment

TECHNICAL MEMORANDUM

Date: August 3, 2018
To: John Rotondo, Rich Rotondo, Rotondo Environmental Solutions, LLC
Copy to: John Lenth, Herrera Environmental Consultants, Inc
From: Dylan Ahearn, Herrera Environmental Consultants, Inc
Subject: Rotondo StormGarden Filter Panel Assessment

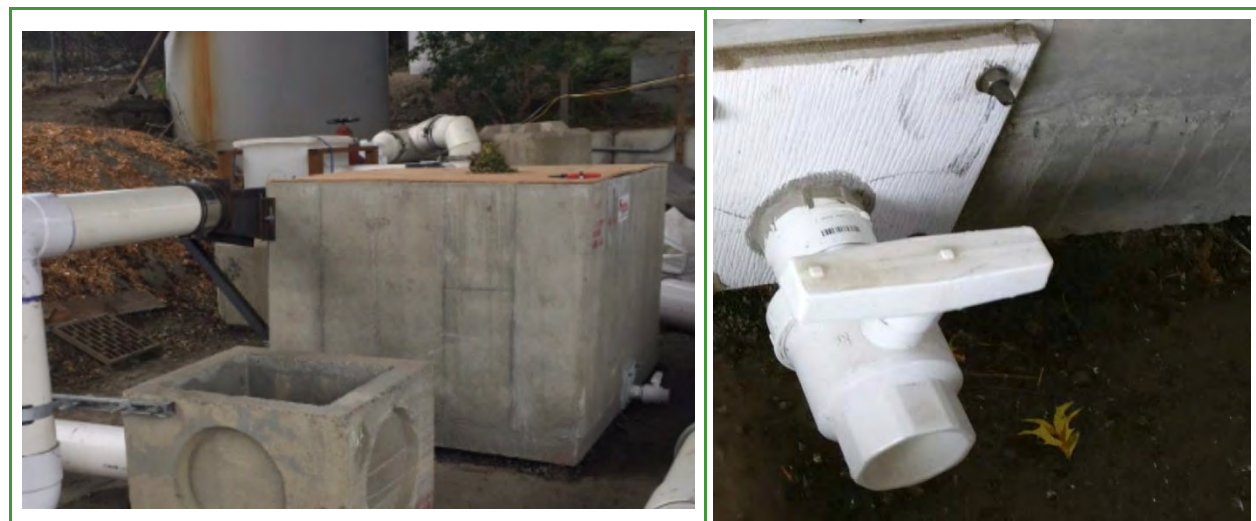
Figure 2. Photos of StormGarden Test System with Filter Panel Valve on the Right Bottom Wall.

To verify the benefits of the filter panel, the StormGarden installed at the SCTF for testing was retrofitted with a cover over the filter panel and a valve attached to the outside of the panel (Figures 1 and 2). The valve remained closed during normal operation and was only opened during discrete testing periods.

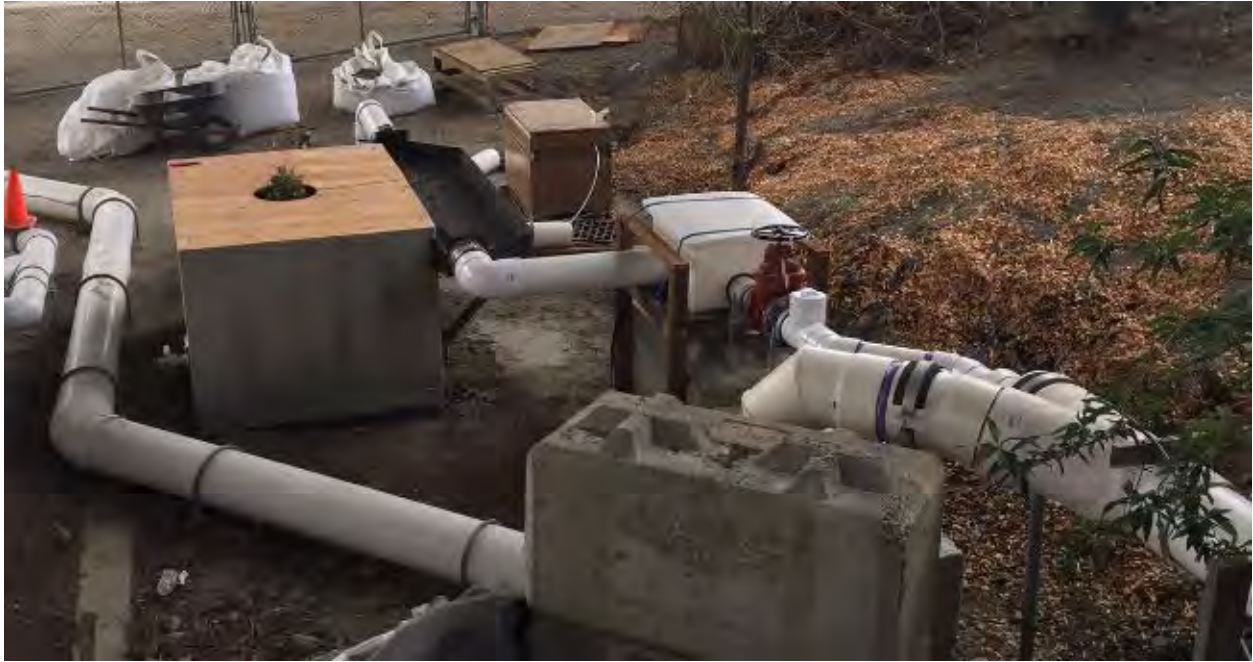
Figure 1. Image of the StormGarden System Tested at the SCTF.

On April 20, 2017, Herrera Environmental Consultants, Inc. (Herrera) conducted infiltration testing on a 4- by 6-foot (internal dimensions) StormGarden Stormwater Filtration System (StormGarden) installed at the Ship Canal Testing Facility (SCTF) in Seattle, Washington (Figure 1). In order to determine the maximum flow rate that the system could infiltrate without bypassing, a firehose with Master Meter™ fire hydrant meter (flow meter) was used to discharge potable water into the system. The flow rate of the flow meter was verified with a calibrated 30-gallon bucket and timer prior to testing, and it was determined that the error was less than 5 percent. Figure 2 provides images of both the flow meter and the graduated bucket.

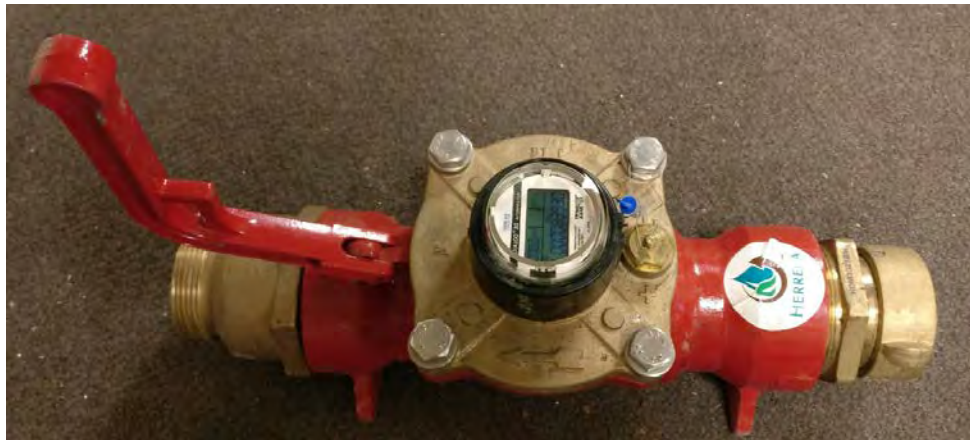
Figure 2. Images of the Rotameter and Graduated Bucket used During the Infiltration Testing.

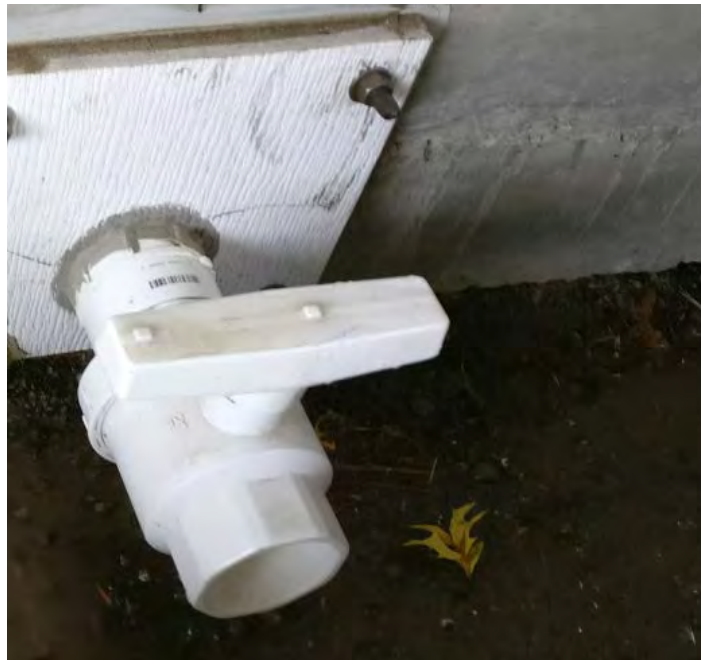
Figure 3. Filter Panel Valve.

The StormGarden is configured with a 4-inch underdrain as well as a 6- by 4-inch permeable paver filter panel that is designed to drain the water beneath the underdrain perforated pipe between storm events. The filter panel also provides some infiltration benefit. During the final run, a valve sealed over the filter panel (Figure 3) was opened and one final infiltration test was run to determine the maximum infiltration rate with both the underdrain and filter panel exporting filtered stormwater. The result was an increased maximum infiltration rate from 213 in/hr to 249 in/hr (Table 1).
