TECHNICAL EVALUATION REPORT

STORMGARDEN[™] BIOFILTER SYSTEM PERFORMANCE CERTIFICATION PROJECT

Prepared for Rotondo Environmental Solutions, LLC

Prepared by Herrera Environmental Consultants, Inc.

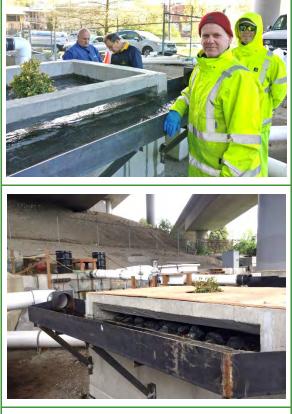
Installation of the monitored StormGarden[™] system at the Ship Canal Test Facility in Seattle, Washington.

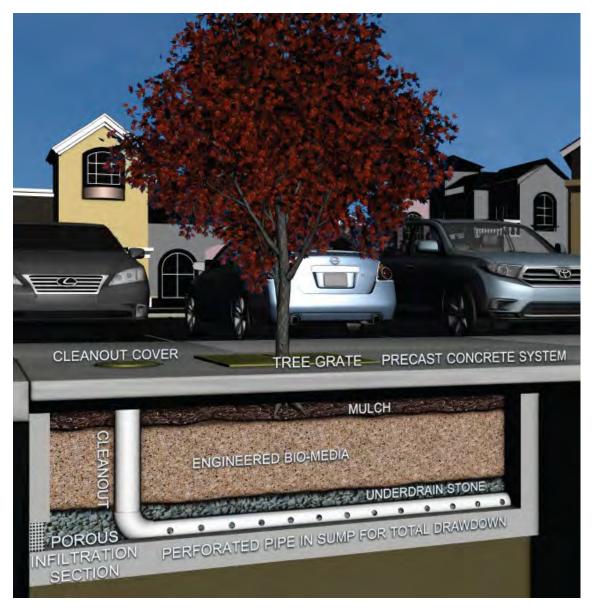
Figure 2. The StormGarden Design.

The StormGarden is a "living filter" that can support flora and fauna while treating stormwater. It uses a horizontal filter bed that incorporates an advanced media designed to remove gross solids, suspended solids, nutrients, metals, hydrocarbons, and other stormwater pollutants. The system tested is a self-contained, curb inlet style, stormwater treatment system that functions as an offline stormwater treatment device (Figure 2). The major components (media, plants, and drainage infrastructure) are packaged in a prefabricated concrete container. The concrete container is covered with a prefabricated concrete top slab with vegetation that extends through a tree grate cast into the top slab.

The StormGarden is housed in a concrete container that is available in a variety of precast sizes (ranging from a 4-foot by 6-foot box to a 7-foot by 13-foot box). Each StormGarden vault is designed and constructed to withstand an H-20 non-live load, which is typical for behind-thecurb applications. The container floor and walls are manufactured from 4- to 6-inch-thick reinforced concrete. The top slab of the StormGarden is manufactured with a minimum of 8-inch-thick concrete. The top slab also contains a standard or decorative tree grate rated to withstand pedestrian loading. A schematic of the StormGarden is shown in Figure 2.

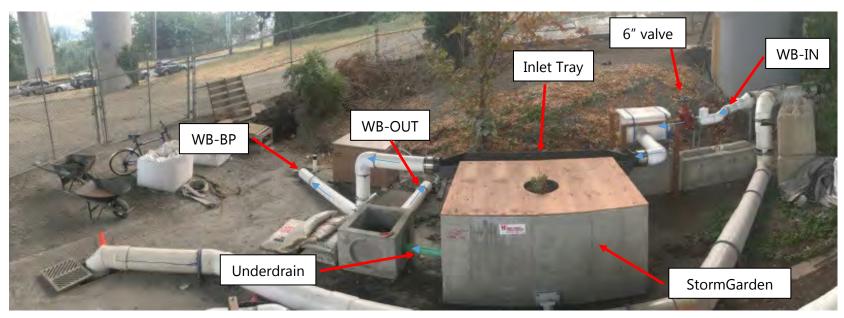
Figure 3. Photo of the Test StormGarden System as Installed at the Ship Canal Test Facility.

Note: Photo was taken from the back side of the unit. Direction of flow is from right to left.
